IDENTIFYING ISSUES ON PHOTOVOLTAIC SYSTEMS USING THERMAL IMAGING

There is more than meets the eye
when doing a PV system inspection-

Fred Brooks, CEM, CEA Level II
Certified Thermographer

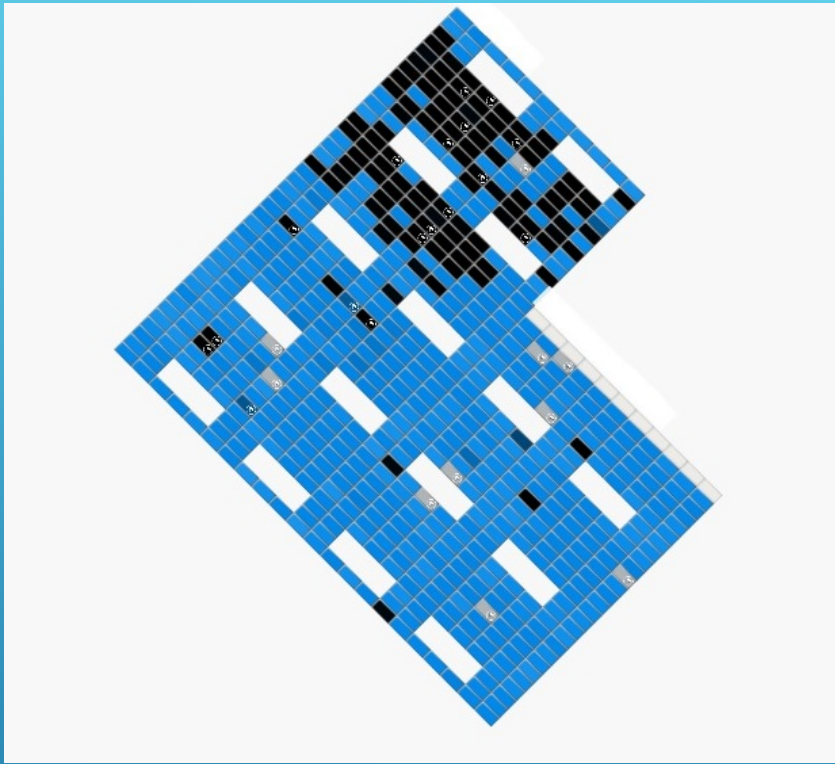
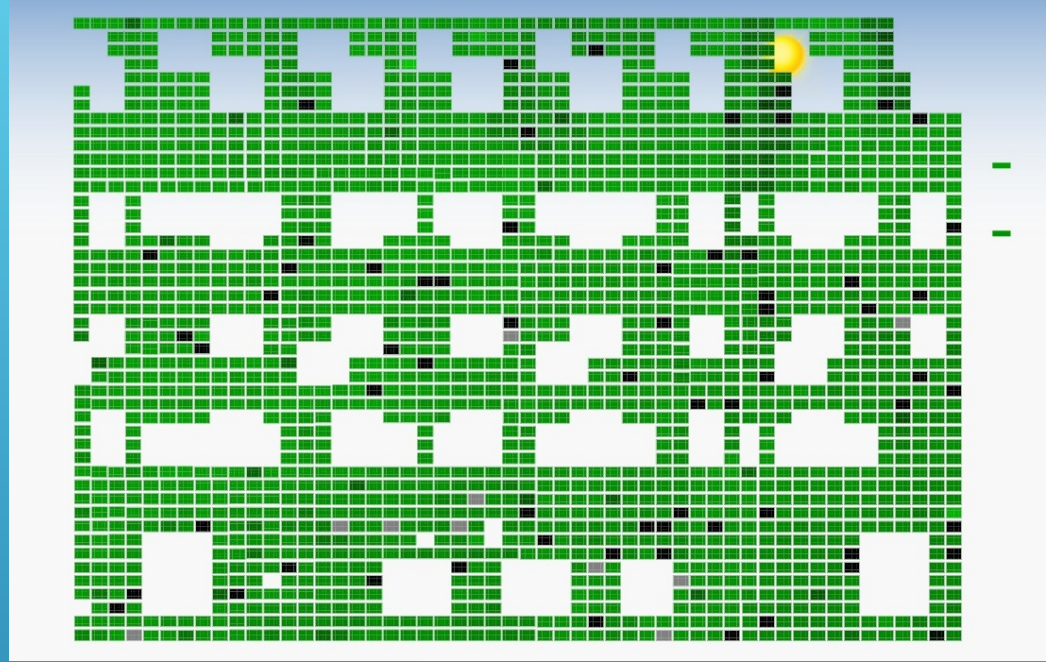
THIS WAS THE LAYOUT WE GOT THERE AND
FOUND THIS WAS REALLY THE LAYOUT ON
THE ROOF

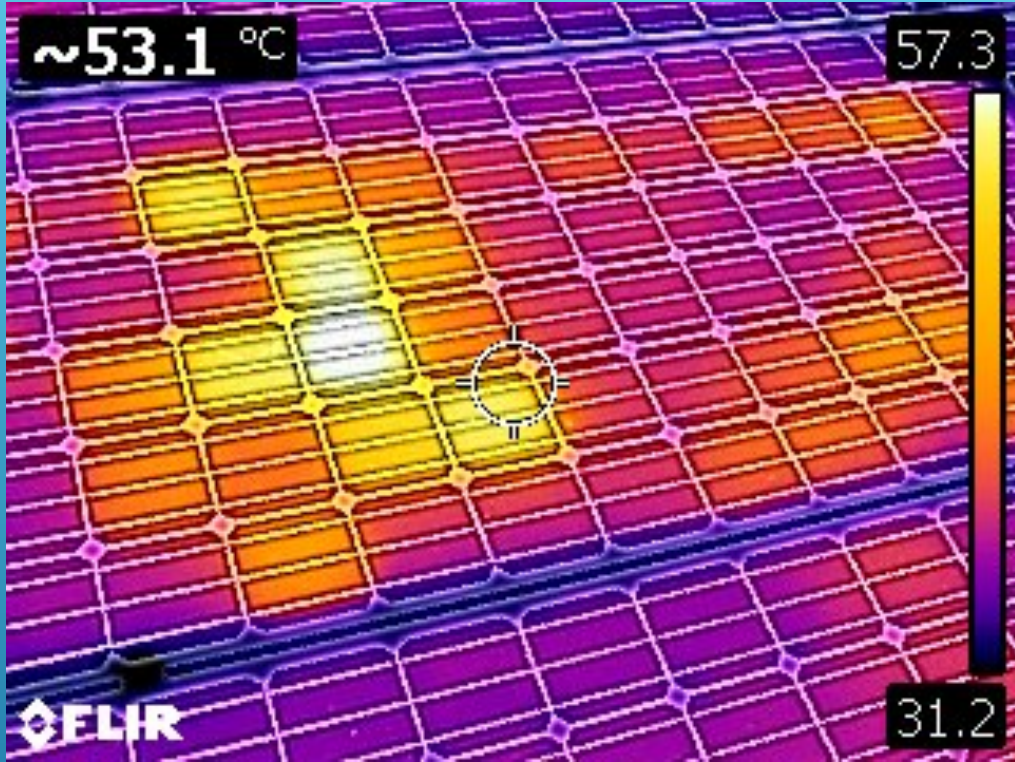
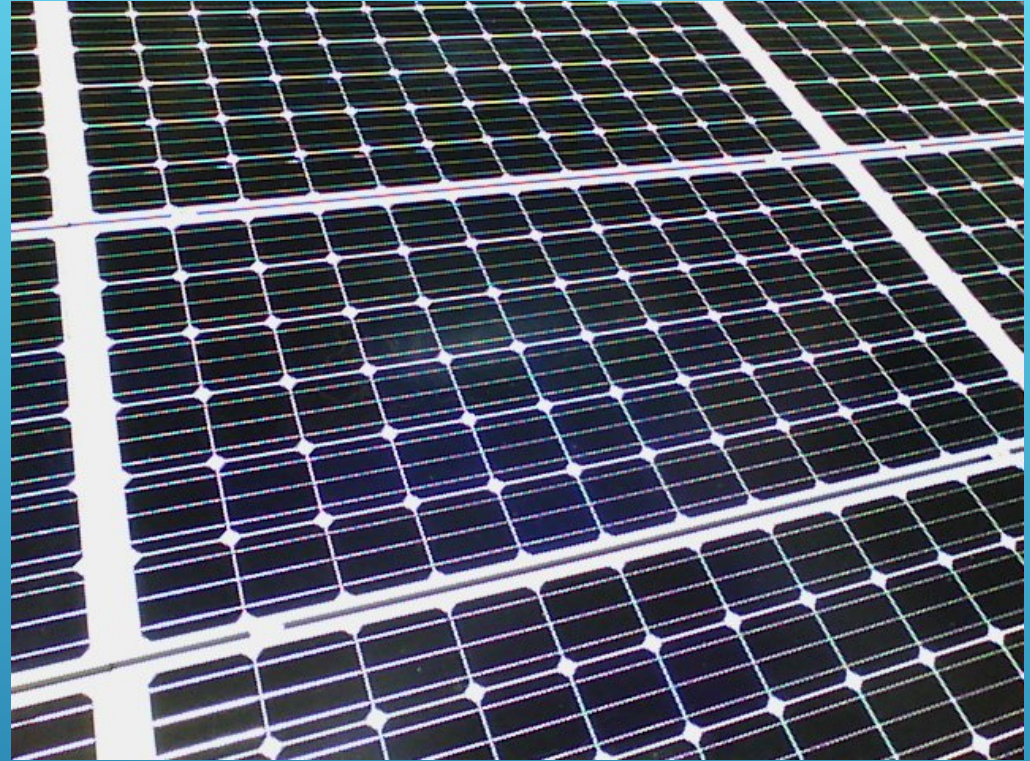
FOUND IT- WITH A DIFFERENTIAL TEMPERATURE OF 1.6°C – NOT PLUGGED IN FOUND THIS DURING A COMMISSIONING CHECK

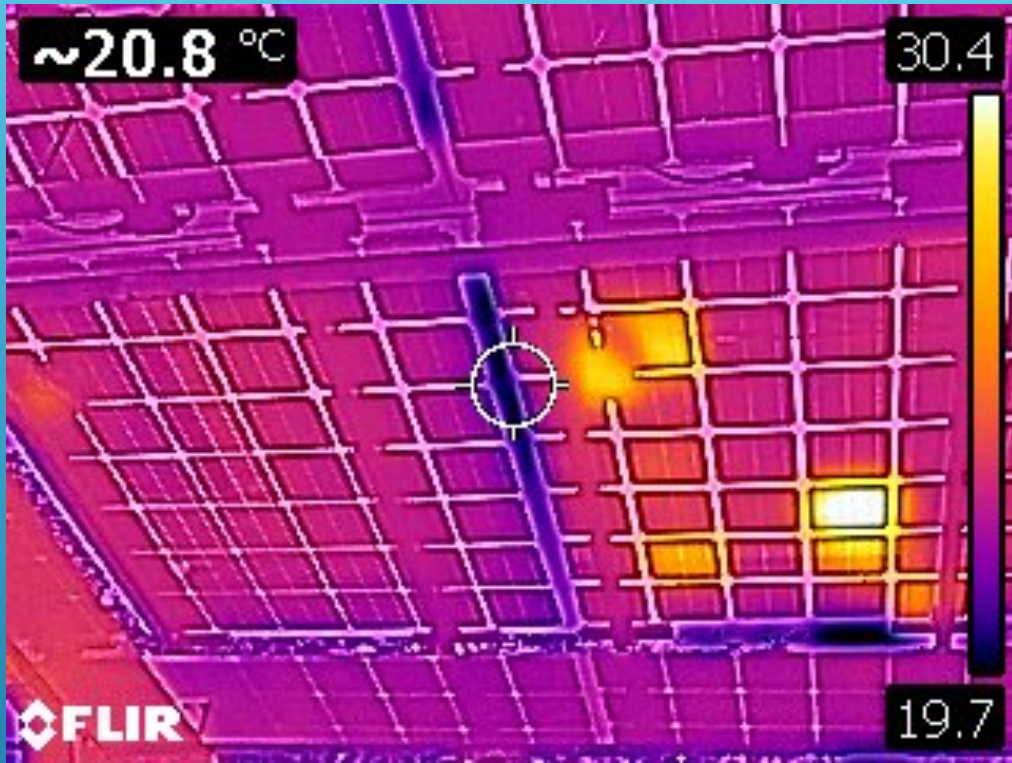
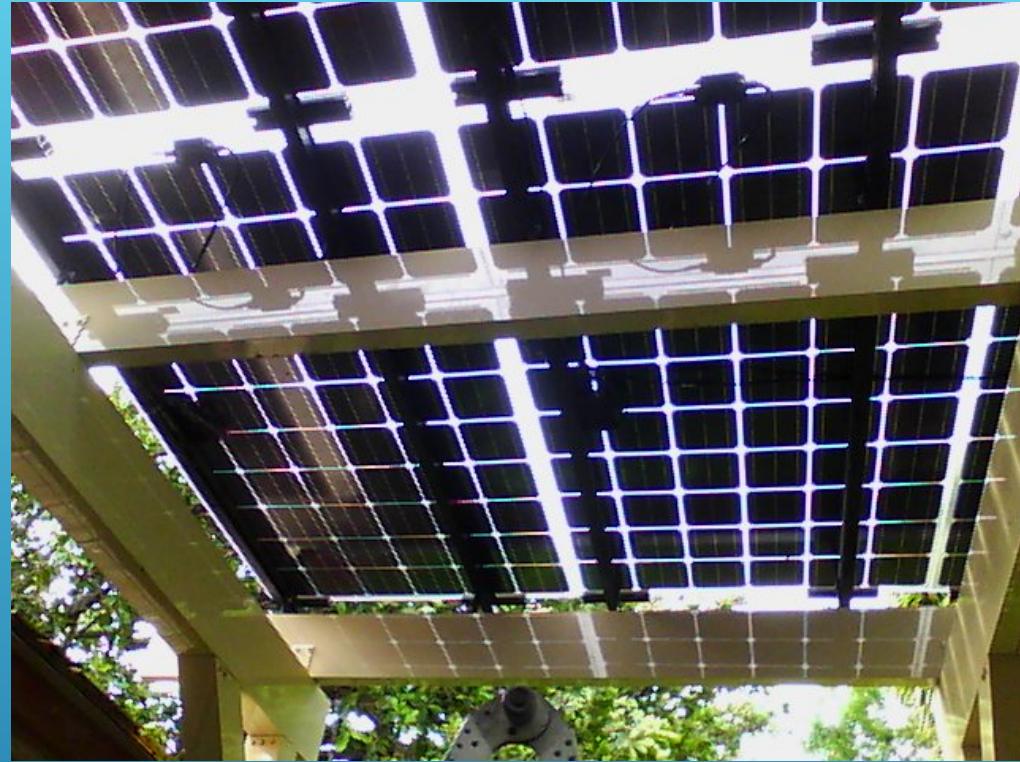
FOUND THIS ONE IN THE MIDDLE WAS
MAPPED FOR A CORNER LOCATION

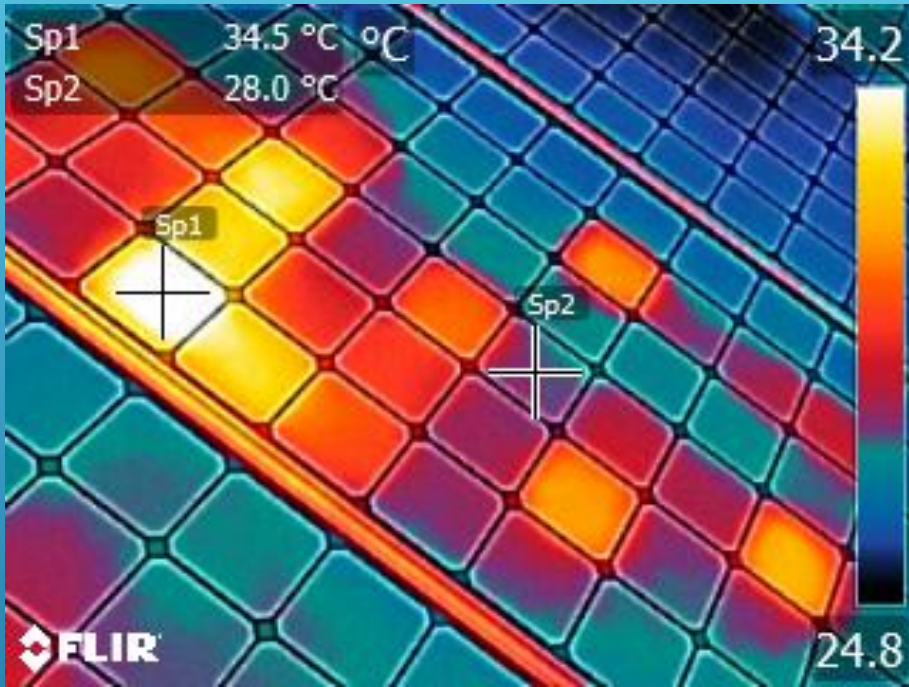
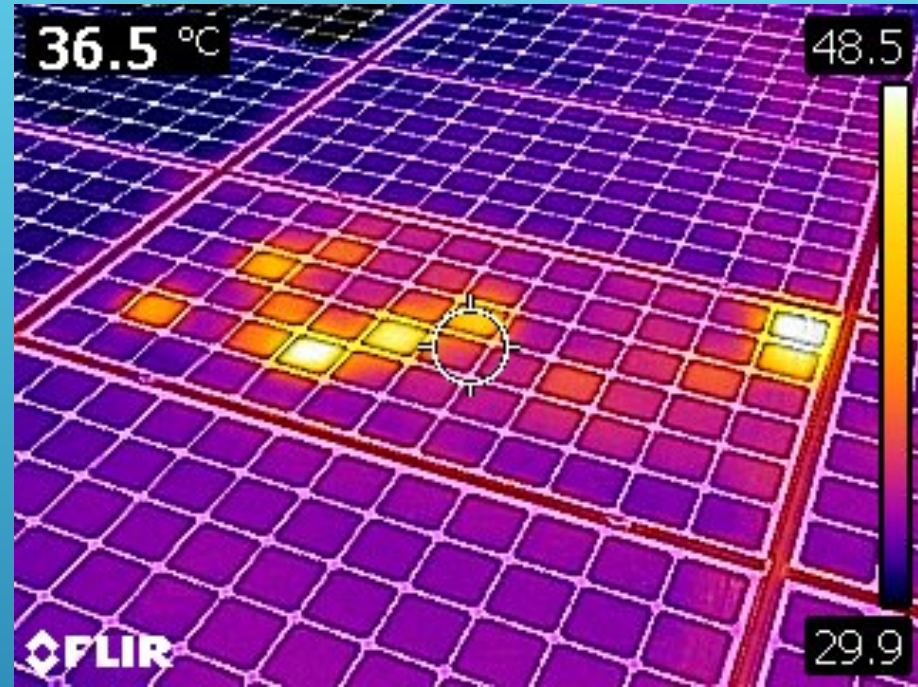
FROM UNDERNEATH OPTIMIZER FAILED
SIGNATURE ON THE PANEL GAVE IT AWAY-
THE MAP WAS NOT EVEN A MAP

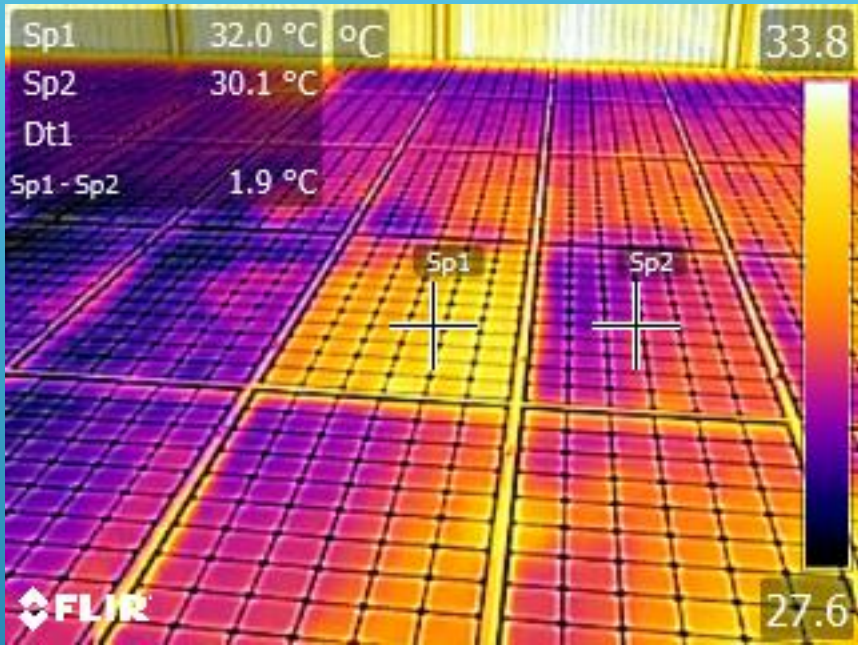
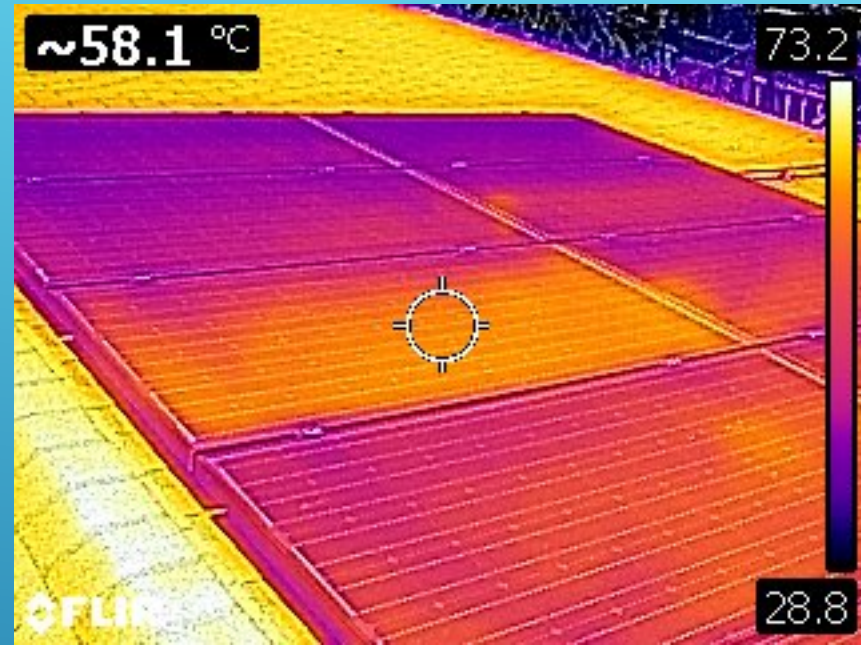
MINOR DIFFERENCES IN TEMPERATURE
THESE ARE JUST 2.4° AND 2.6°C

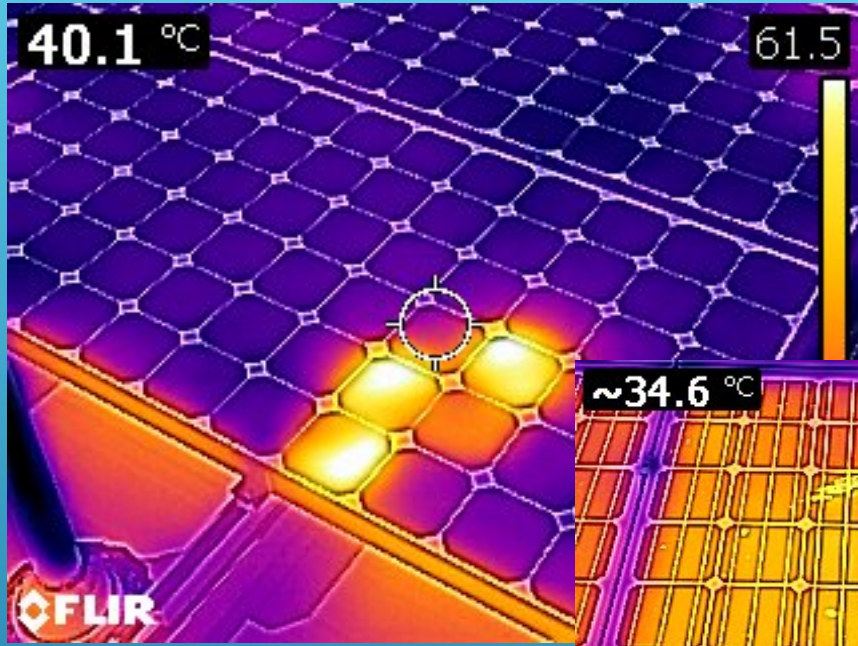
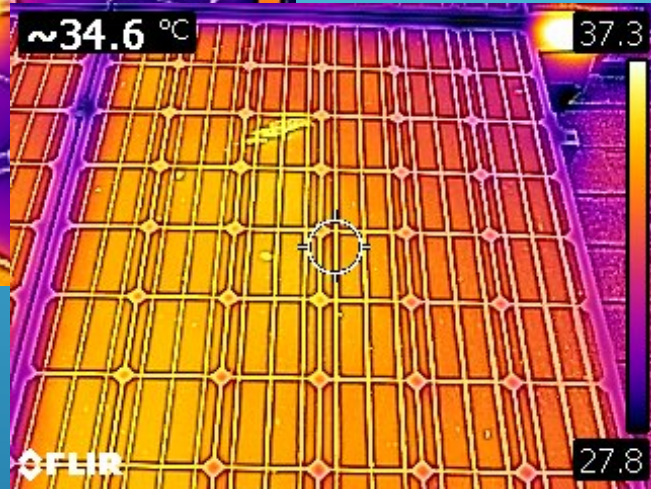
INFORMATION TO KNOW

- ▶ We were told this has to be a major issue but the panel does not seem to have a problem –
- ▶ We asked for the digital images as we had an idea of what they were

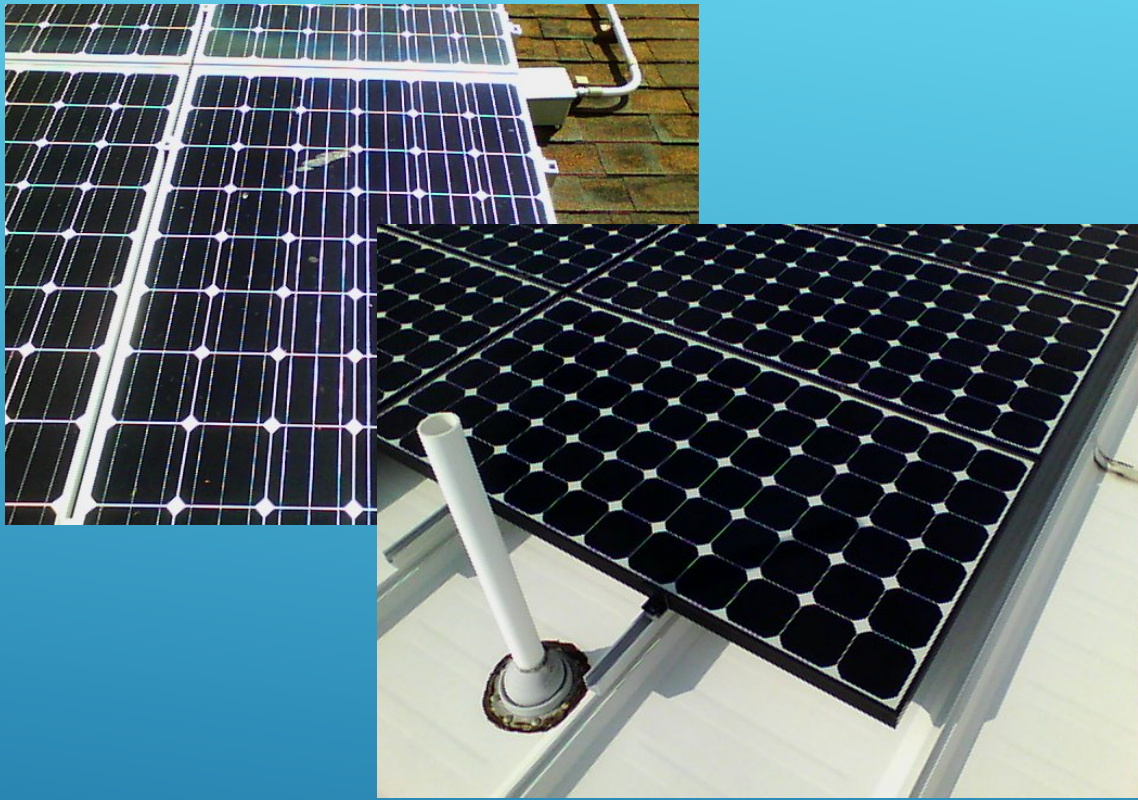
- ▶ Keep a clear picture in your head, it is good to see an anomaly but understand it
- ▶ The bird poop and the shadow from the vent caused the anomalies-
